SHOWAIRREJ TO TAK HARB ROAD PAVING COMMANDER'S EMERGENCY RESPONSE PROGRAM NINEWA GOVERNORATE, IRAQ

SUSTAINMENT ASSESSMENT

SIGIR PA-07-107 OCTOBER 22, 2007

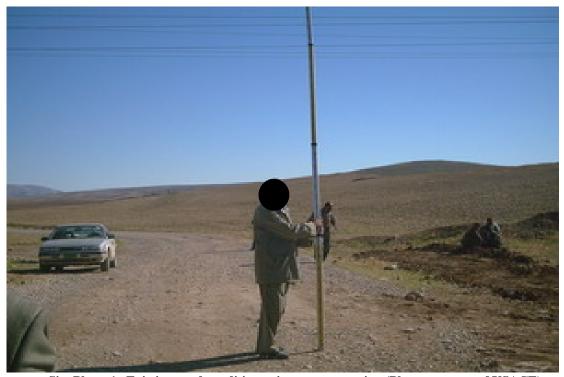
Site Photo 1 documents the condition of the road prior to the commencement of the construction of the main rural road. The contractor removed excess road materials so the road elevations would be level. Site Photo 2 documents the removal of the excess road material; while Site Photo 3 shows the contractor excavating the road. The contractor leveled the road, which is shown in Site Photo 4. In addition, the contractor utilized rubber tire pneumatic rollers and steel drum rollers to compact the sub-base as shown in Site Photo 5. In Site Photo 6, the contractor has supplied sub-base material for the road. The tack coat application to the sub-base is shown in Site Photo 7.

Site Photo 1. Existing road condition prior to construction (Photo courtesy of USACE)

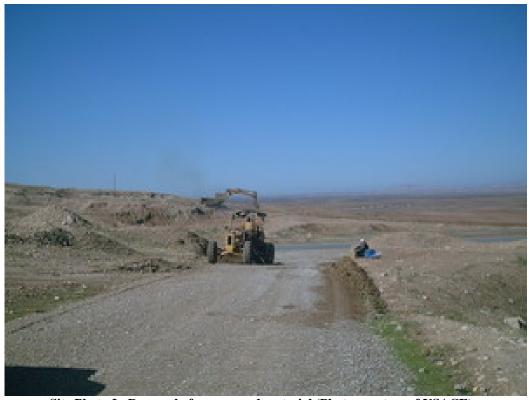
Site Photo 2. Removal of excess road material (Photo courtesy of USACE)

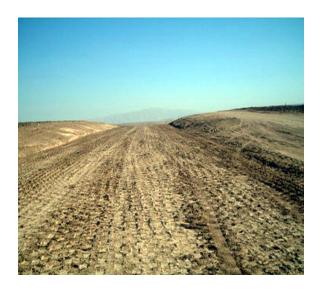
Site Photo 5. Road compaction (Photo courtesy of USACE).

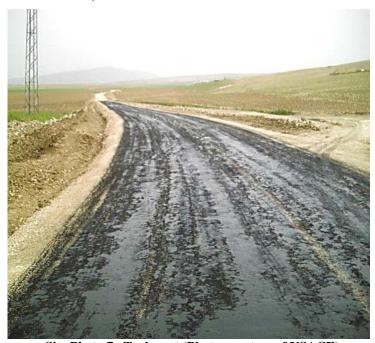
Site Photo 7. Tack coat (Photo courtesy of USACE).

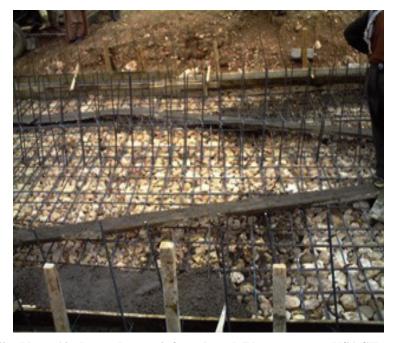
The box culverts documented in the quality assurance (QA) reports were constructed as cast-in-place reinforced concrete structures. Site Photo 8 shows the culvert concrete testing. The box culvert construction, and reinforced steel application for the top slab prior to concrete placement are shown in Site Photos 9 and 10.

Site Photo 10. Box culvert reinforced steel (Photo courtesy USACE).

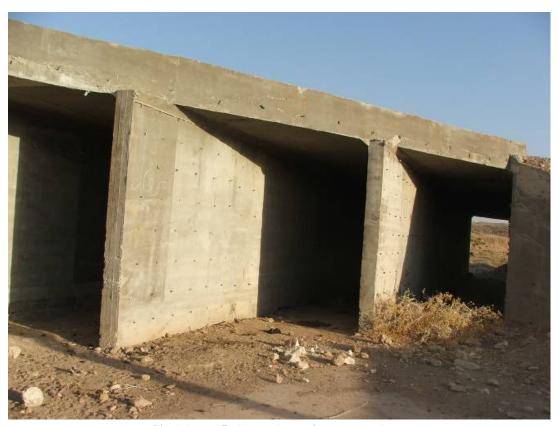
During our site visit, we did not detect any instances of incomplete road construction. The constructed road and box culverts are shown in Site Photos 15 and 16.

Site Photo 15. Box culverts for new road.

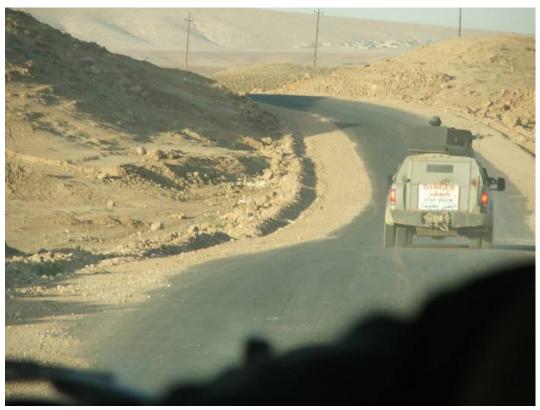
Site Photo 16. New road in use.
